TECHNICAL REPORT 88-2

RUBBLEIZING P.C.C. PAVEMENT- CONSTRUCTION TECHNIQUES AND OVERLAY PERFORMANCE

David W. Bernard
Civil Engineer I (Materials)

February, 1988

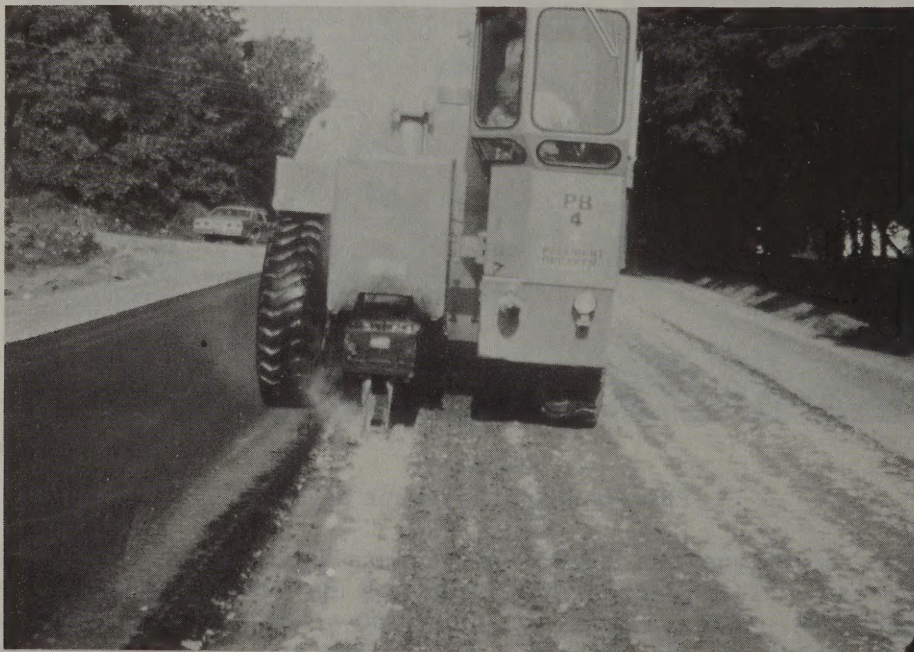
Photo #2

PB4 rubbleizes concrete pavement lane adjacent to previous days construction
